A & R DEPARTMENT NARRATIVE CODE SHEET

NASC:113:dj
Ser: 965
25 April 1963

Subj: VX-5 AAR ser 1-62 concerning A-4C (A4D-2N) BuNo 145066 accident
occurring 25 September 1962, pilot (b) (6)

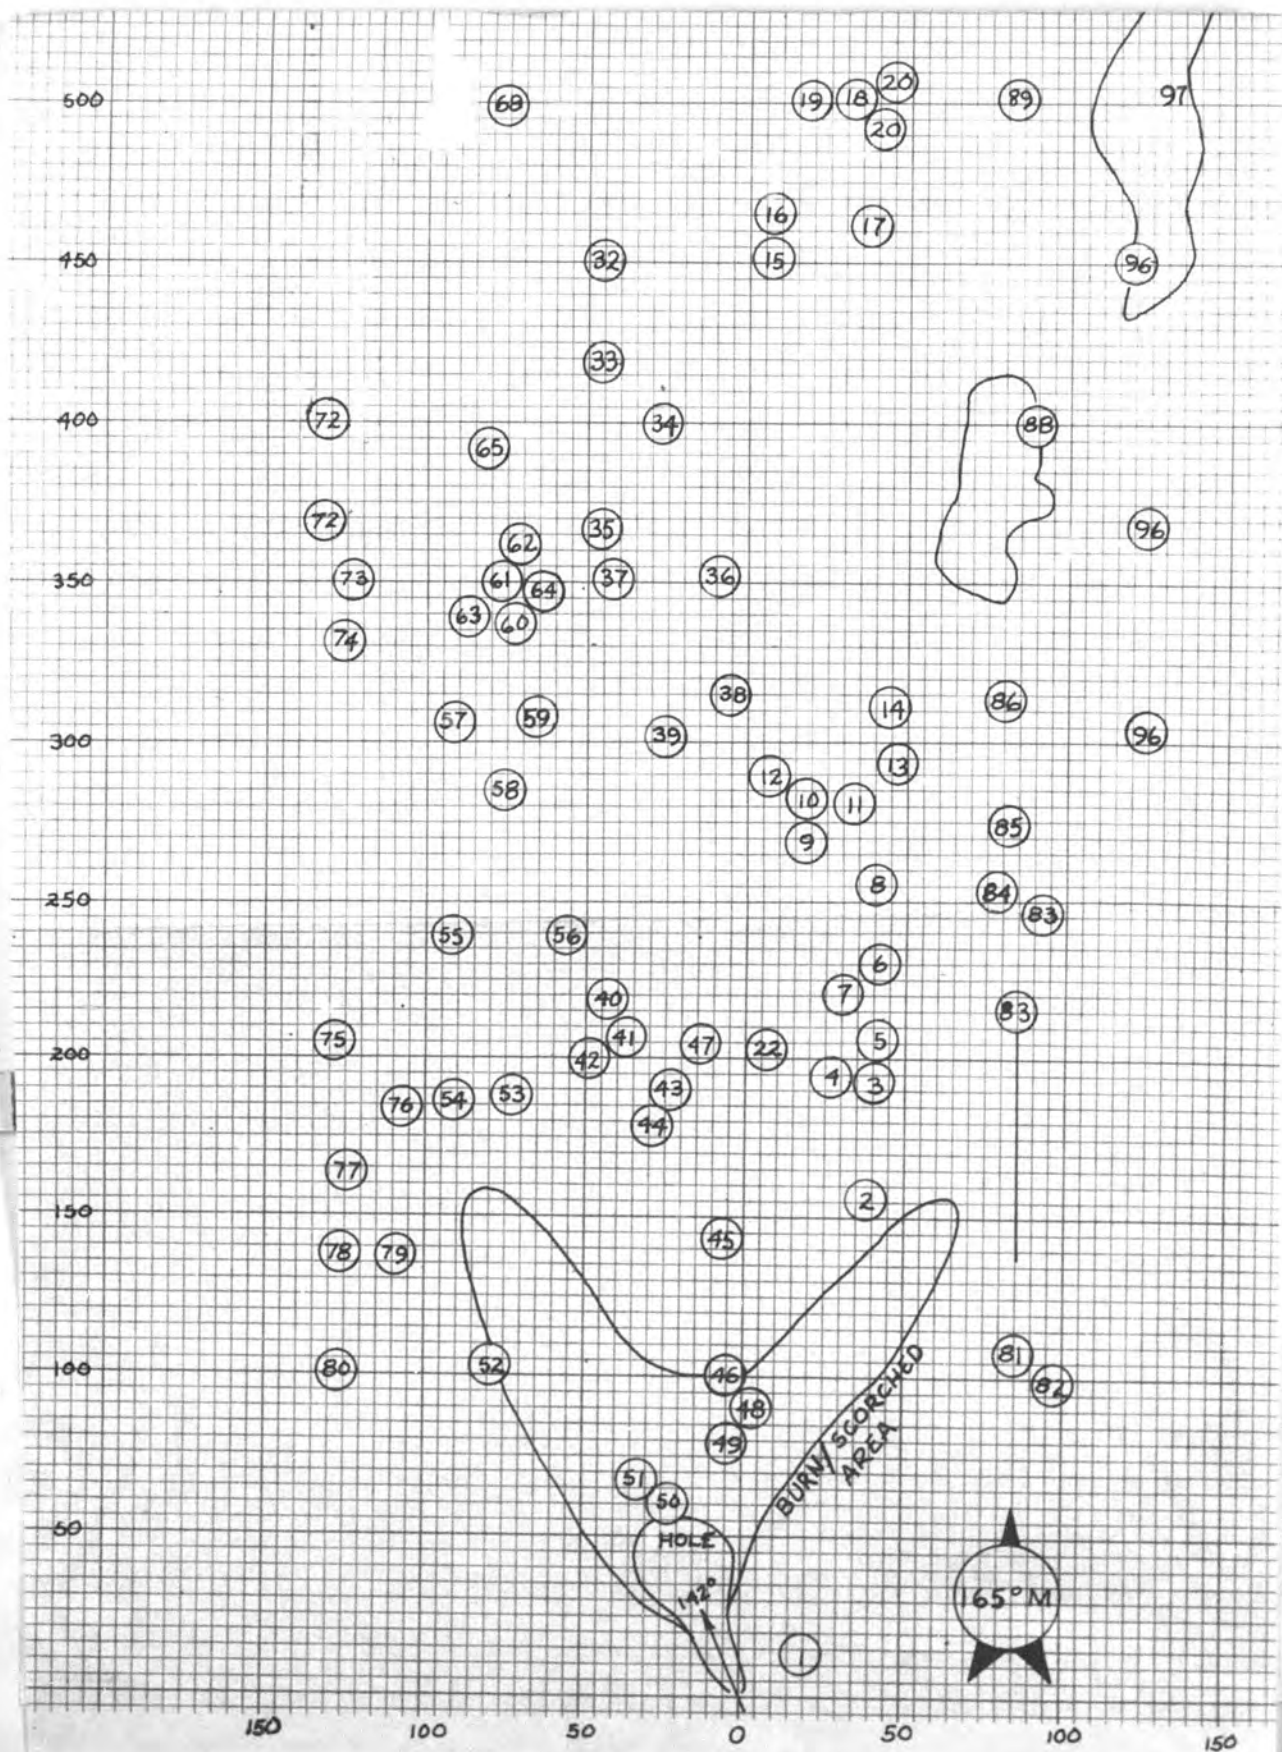
LEGEND FOR WRECKAGE DIAGRAM

1. Alternator
- 2* Portion of fuel line
- 3* Small part fuel tank baffle (burnt)
4. Hydraulic activator
- 5* Small part of fuel cell
6. Piece of rudder
- 7* Piece of backing board
- 8* Part of fuel cell
9. LOX container (inside)
- 10* Small part of fuel cell
- 11* Small part of fuel cell
12. Portion of pilots knee board
- 13* Small portion of fuel cell
- 14* Piece of backing board (burnt)
15. Left aileron
16. Stator blades - 1st stage
17. Stator blades - aft stages
18. Starboard portion of fuselage (oil vent)
19. Gunsight
20. Stator blades
21. N.A.
- 22* Fuel float shut-off casing
23. Piece of compressor case
- 24* Fuel Level Control valve
25. Bomb sway brace

- 56* Piece of fuel cell
- 57* Portion of fuel transfer pump
- 58* Small piece fuselage fuel cell
- 59. Starboard flap
- 60* Wing fuel filter
- 61* Two main fuel fittings
- 62. Throttle quadrant section
- 63* Aft section of main fuel cell
- 64. ASN-19 - 1D 307/ARN
- 65. Port wing, canopy lock lever, emergency hydraulic handle
- 66. APA-89 parts
- 67. Rate of climb indicator (3000 min decent)
- 68. Air conditioning parts
- 69. Radio gear
- 70. Starboard catapult hook assembly
- 71. ASQ-17
- 72* Two fuel fittings #1A880
- 73. Port speed brake
- 74. Drop tank parts
- 75* Remote fuel shut-off valve A6-7544413507 fuel line
- 76* PRESSURE FUEL VALVE
- 77. Two pilon covers
- 78. Main mount
- 79. Port strut and assembly
- 80* Small fuel hose
- 81* Small piece backing board.
- 82* Small piece of fuel cell

The main dispersal of the wreckage was scattered beyond the impact point covering an area of approximately 1000 feet in length and 450 feet in width; isolated parts were found as far as 2000 feet from the impact point. The impact crater was approximately 56 feet in length in a southeasterly direction, 24 feet in width, and varied in depth from negligible at initial impact at the northern end to 9 feet in depth at the southern end.
